## *BrakeTech USA*

August 2014

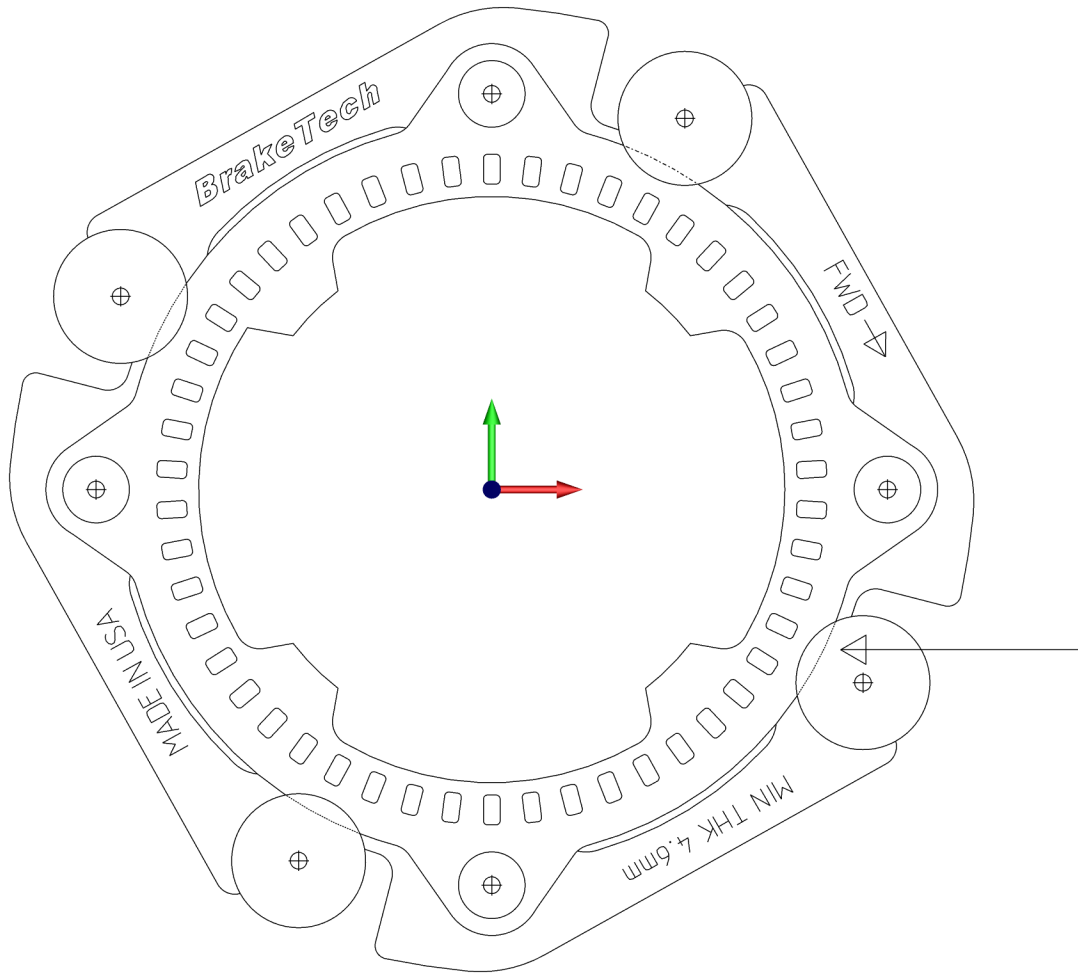
Diagram here shows the light modification of the OE ABS Sensor Ring required for proper fitment of the AXIS series full-floaters

In the case of the Kawasaki's The rolled over lip on the O/D needs to be ground off as well as a small rounded radius to clear the bobbins (shown as dotted lines)

This fitment modification is representative for nearly all models utilizing ABS sensor rings
